Fatigue Testing of Maglev-Hybrid Box Beam

This report summarizes the results from the ONR project "Fatigue Testing of Maglev-Hybrid Box Beam". The project concerned fatigue testing and numerical evaluation of a steel / composite hybrid girder. The girder was previously built under collaboration between Maglev Inc. and Lehigh University. The girder was instrumented with strain gages and LVDT's to monitor strains and deflections. A test setup with bottom supports and towers for mounting two or three hydraulic actuators was installed in the ATLSS test lab. The girder was fatigue tested for over 300,000 cycles at loads up to 120% of design load. There was extensive cracking in the steel structure, but only minor damage in the composite panels towards the very end of the test. No damage in the adhesive joints was found. All items included in the proposal were fully addressed. Reports have been prepared for publication in scientific journals. The results have been instrumental for the design and manufacturing of an instrumented slamming test facility presently being developed under an ONR grant.

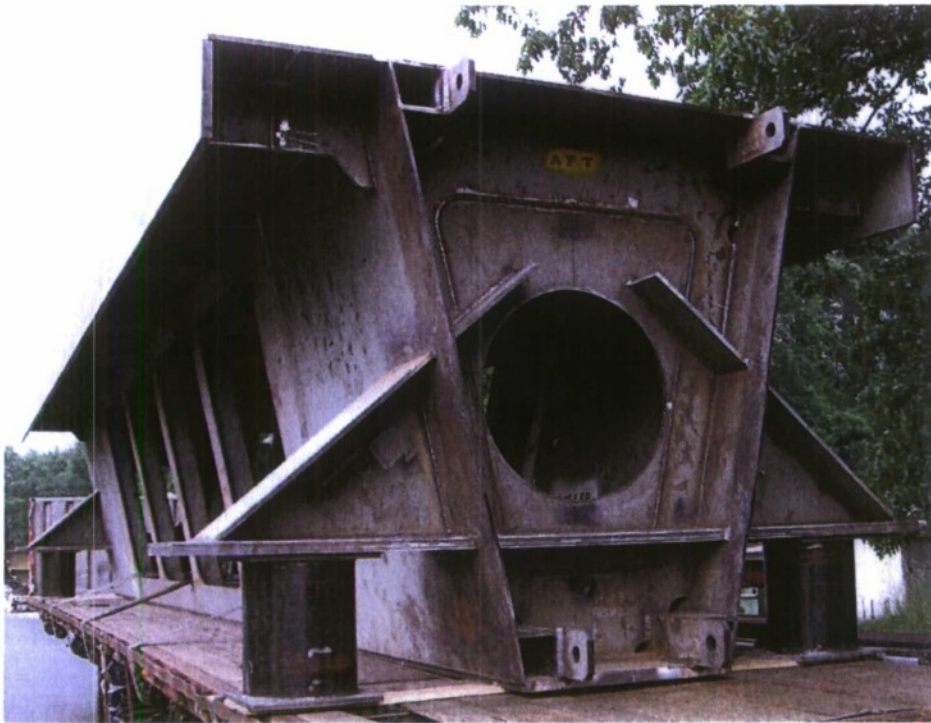
**Fig. 1.** Steel part of the steel/composite hybrid girder.

The objective of the study was to fatigue test the steel/composite hybrid girder shown in Figs. 1-2. The eight stainless steel "window openings" were closed out with vacuum infused glass fiber skin / foam core sandwich panels. The panels were bonded to the steel frame with an epoxy paste adhesive. No mechanical fasteners were used. Six of the eight panels were conventional sandwich panels with a uniform core thickness up to near the edges, where the core tapered off and the two skins joined. The last two panels had deeply corrugated inner skins and flat outer skins. The corrugated panels were lighter and presumably stronger than the conventional ones. The two different panel configurations are shown in Fig. 3.
